Manhole Inspection Summary

Manhole # S49II_012MH

Location Address: **Llewelyn**

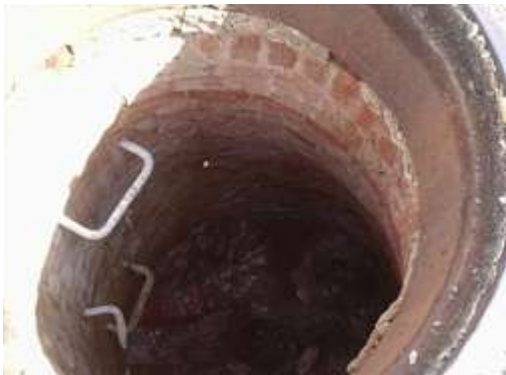
Defect 1

Infiltration: ☐ None ☒ **Joint** ☐ Cracks ☐ Mortar ☐ Roots ☐ Wall

Infiltration: ☐ None ☐ Joint ☐ Cracks ☐ Mortar ☐ Roots ☒ **Wall**

infiltration

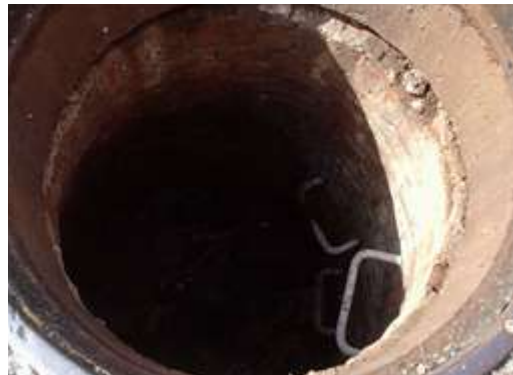
Defect 2

frame leaks

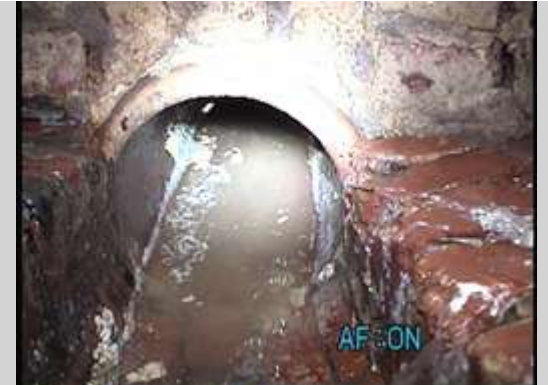
12 O'Clock Outflow

8 in. Circular Gravity Sewer
Pipe Out @ 12 O'Clock

Pipe Height: **8.4** (in.) Rod and Bar (Angled)
Pipe Material: **Clay** ☐ Pipe Lined
Invert Depth: **8.05** (ft.) Flow Characteristics: **Slow**
Deposits: ☒ None ☐ Mud ☐ Sludge ☐ Debris ☐ Grease
Silt Depth: (in.) Deposits Extent:
Infiltration: **None** Pipe Seal Cond: **Sound**

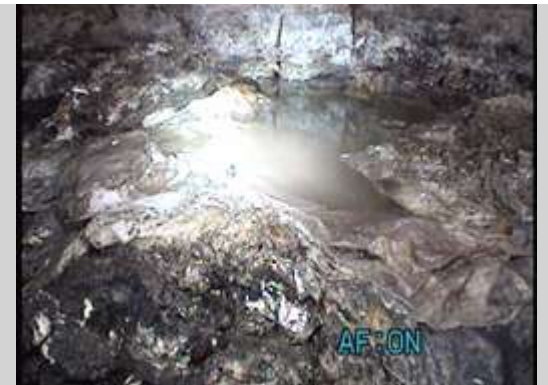
3 O'Clock Inflow

8 in. Circular Gravity Sewer
Pipe In @ 3 O'Clock

can not get good pic because of debris

Pipe Height: **8.4** (in.) Rod and Bar (Angled)
Pipe Material: **Clay** ☐ Pipe Lined
Invert Depth: **7.95** (ft.) Flow Characteristics: **Slow**
Deposits: ☒ None ☐ Mud ☐ Sludge ☐ Debris ☐ Grease
Silt Depth: (in.) Deposits Extent:
Infiltration: **None** Pipe Seal Cond: **Sound**
